Inflatable Barriers Ease Dock and Lock Gate Repairs Smarter – Faster and More Efficient!

In the Maas River, there is a lock from the sea where ships are lifted from approximately 56 to 488 NAP (Normaal Amsterdams Peil).

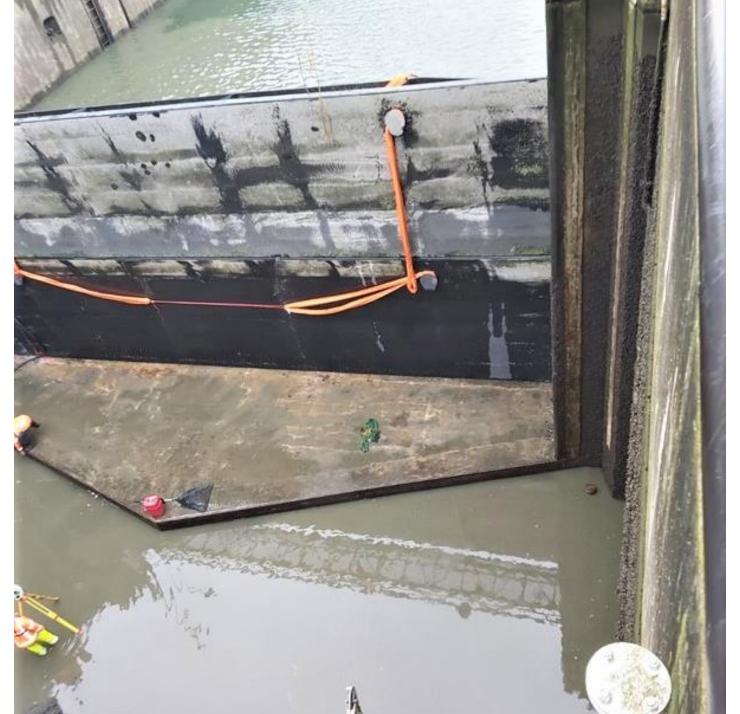
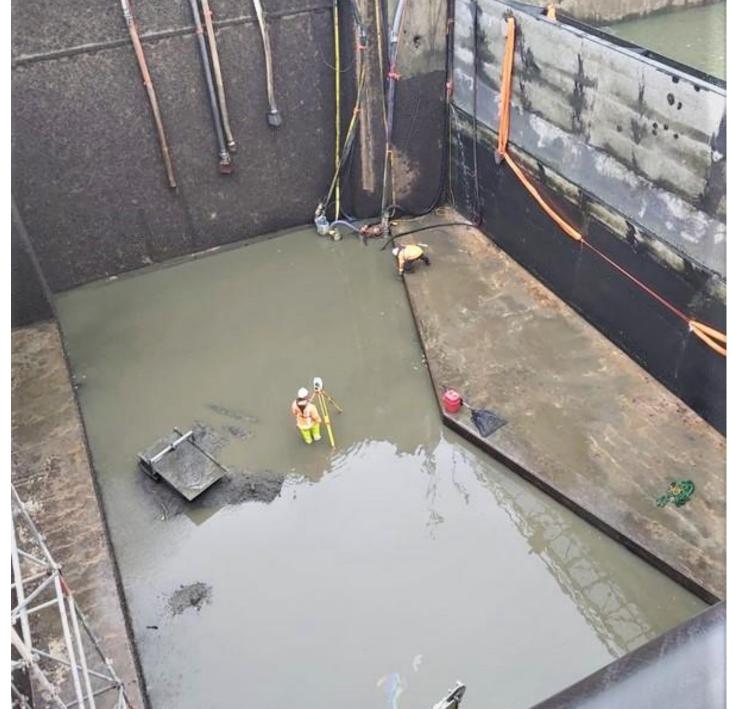
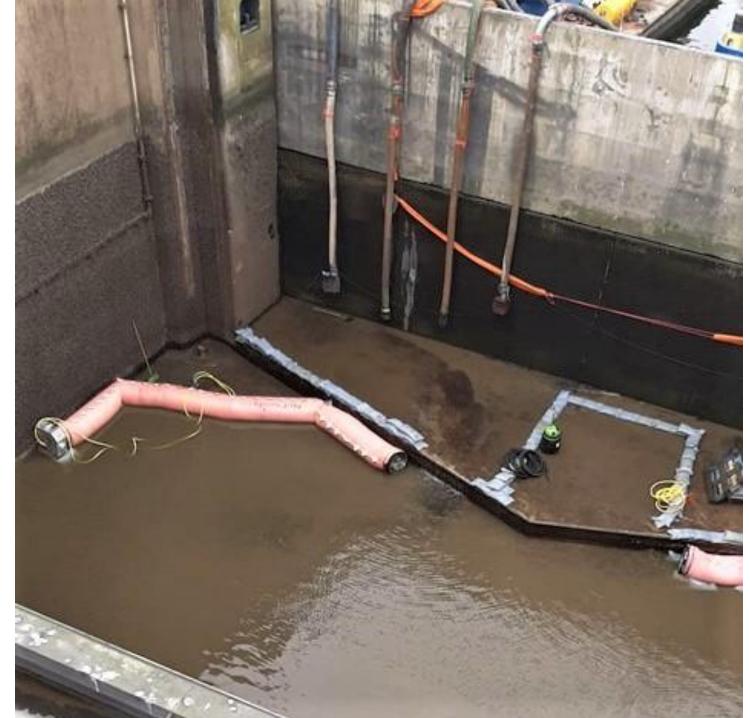
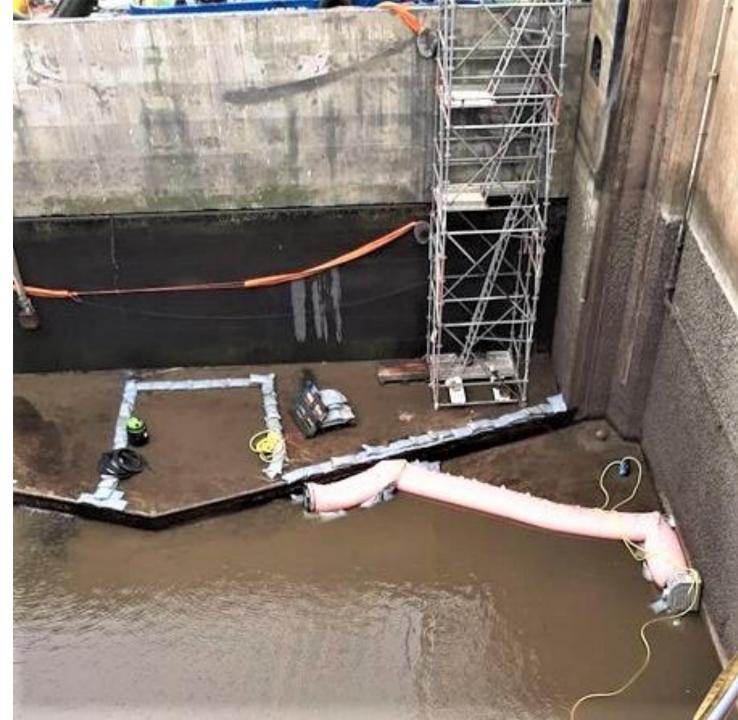
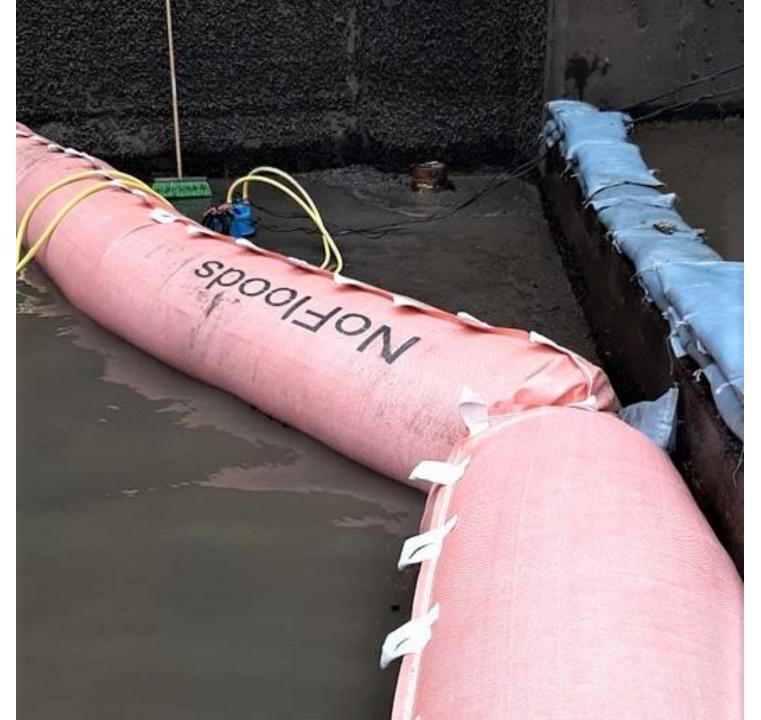
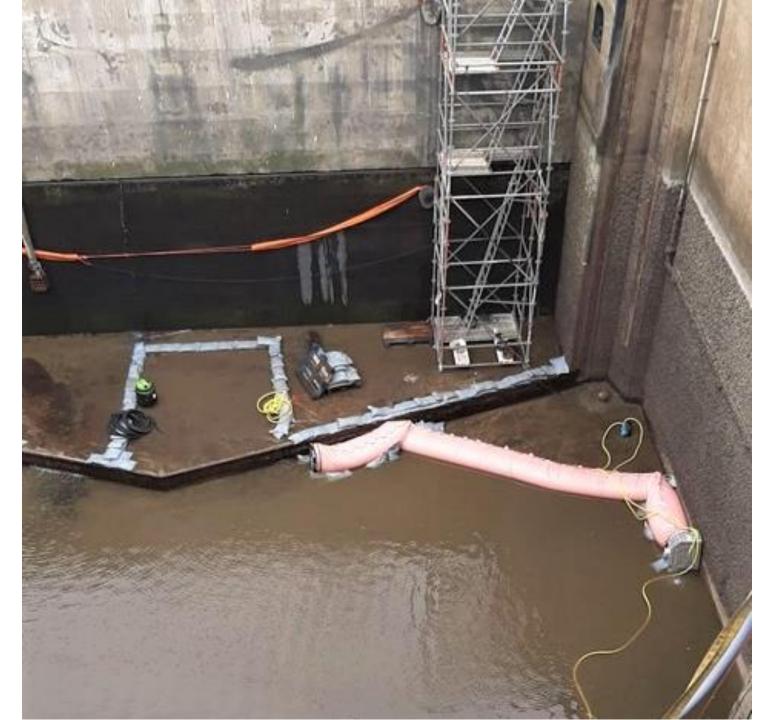
Our Dutch partner advised the client to place our NoFloods barriers at the corners of the lock heads to create a small cofferdam (dry work area) and enable the replacement of the pivots. After consultation with our head office in Denmark, the client agreed and used the NoFloods Pro 60 barrier.

The barrier proved to be fast and practical they were quickly able to keep the corners dry.
