THE NEW GENERATION OF FLOODPROTECTION

CASEBOOK

LIST OF THE CASES IN THIS BOOKLET

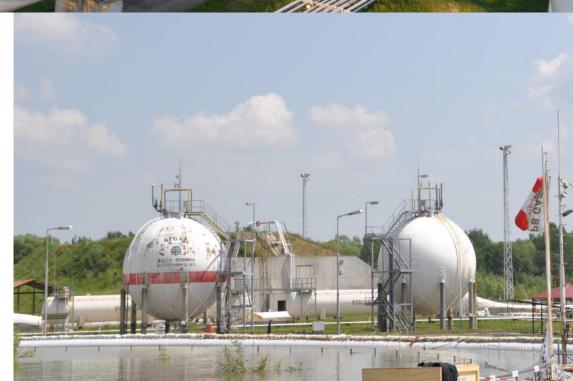
NoFloods Barrier saves Gas Plant from flooding

Within six hours after their arrival a team of 3 people had fully deployed the mobile barrier and surrounded the plant completely.

Utilising the floodwater to fill the tubes, the 400-metre barrier was deployed from June 6 to June 12. Despite a recommended maximum flood retention height of 80 cm, the NoFloods Barrier TwinTube 125 held back the rising floodwater, which rose to a height of 92 cm.

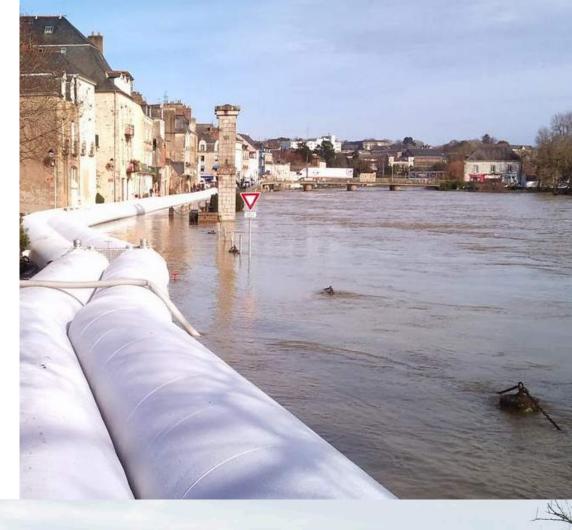
Pontivy, France

Vive la France, Vive NoFloods!

When extensive rain caused the water to rise in the Oust and Blavet rivers, the towns of Josselin, Pontivy and Redon deployed the NoFloods Twin Tube 125cm Barrier to protect their residents from potential damage. Fortunately, the situation only became serious in the rue des Moulins in Pontivy, where the NoFloods Barrier successfully held back the water that rose to a level that threatened people and infrastructures.

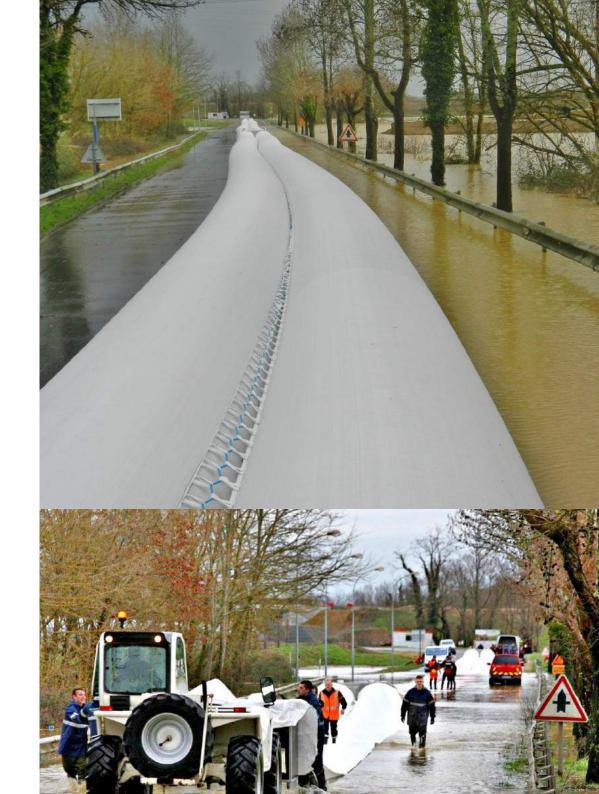
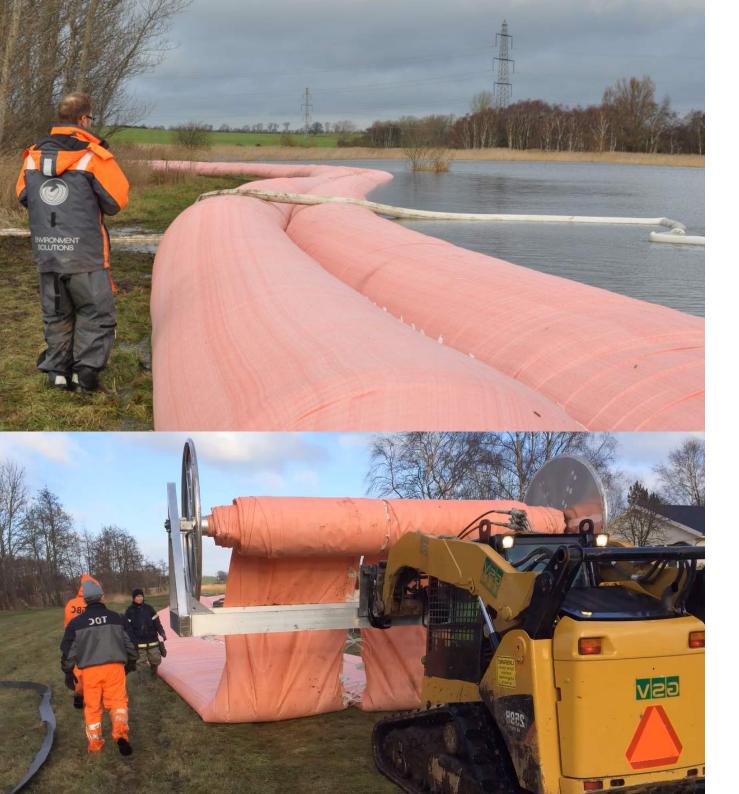
Jyllinge, Denmark

Realisation of an effective flood management plan

However, the storm in January 2015 had a different and much happier outcome than was the case in December 2013. The emergency planning department had made a plan, and the NoFloods Barriers played a major role. In plenty of time before the climax of the storm, Environment Solutions had laid out approximately 1000 metres of NoFloods barriers, successfully protecting the lowest lying areas against the fjord waters and against the elevated water level in the watercourses.

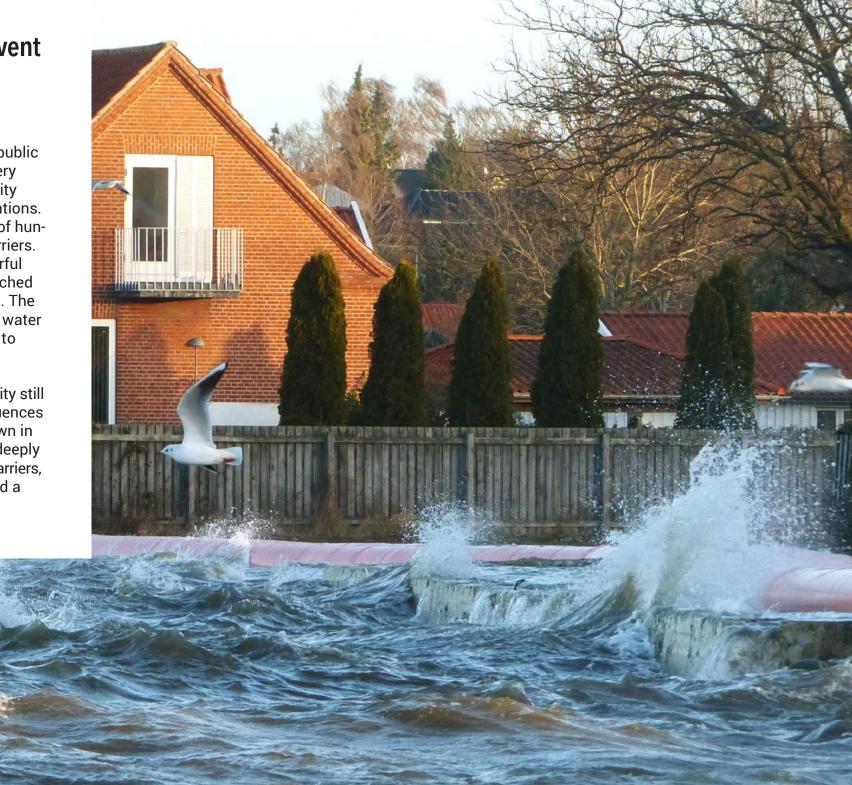
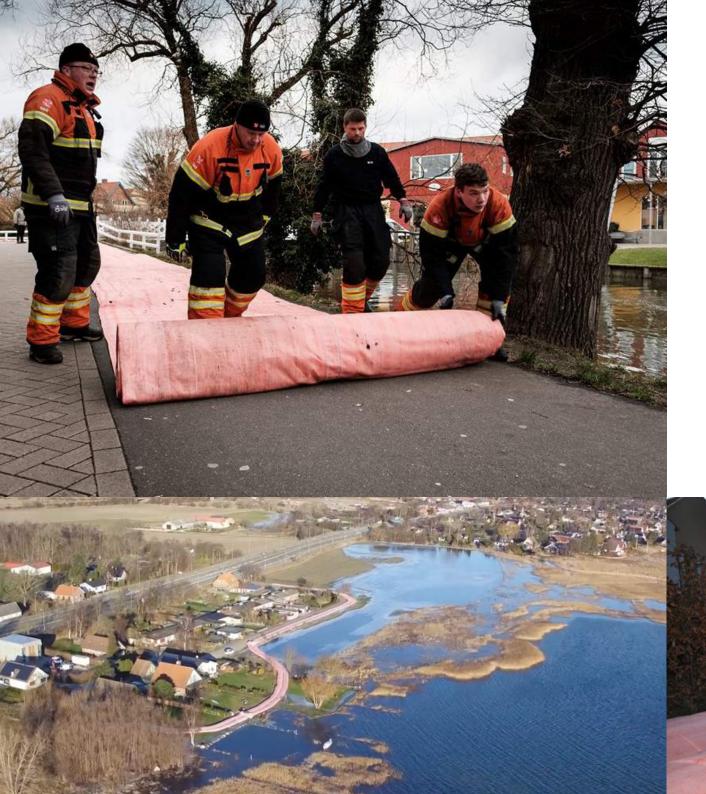
Køge, Denmark

Highest water increase in 100 years

In Køge Municipality the NoFloods water tubes were deployed in two strategic locations to maximise their protective effect. While private citizens made extensive use of sandbags to protect their basements or the entrances of their houses, the NoFloods barriers were clearly the perfect solution for the rapid protection of a big area, requiring only a few men.

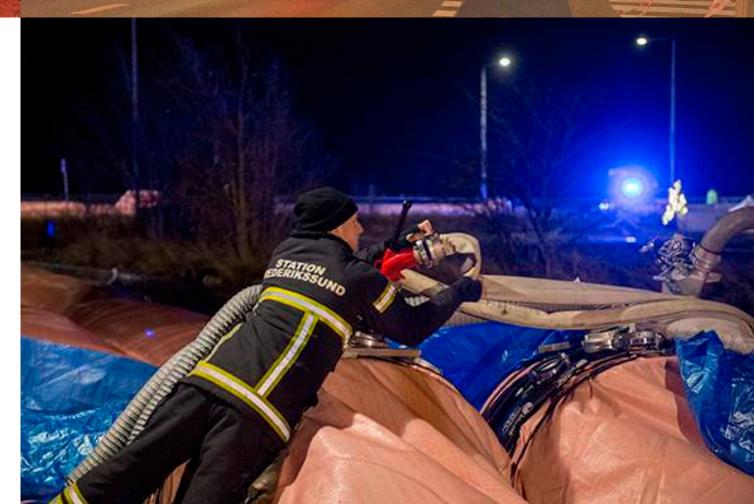
Frederikssund, Denmark

'Christmas present' for Frederikssund municipality

In 8 hours, volunteers in different vulnerable locations in the Municipality deployed a total of 1,400 metres of water tubes. The barriers were deployed until 28 December and their presence prevented a huge amount of damage.

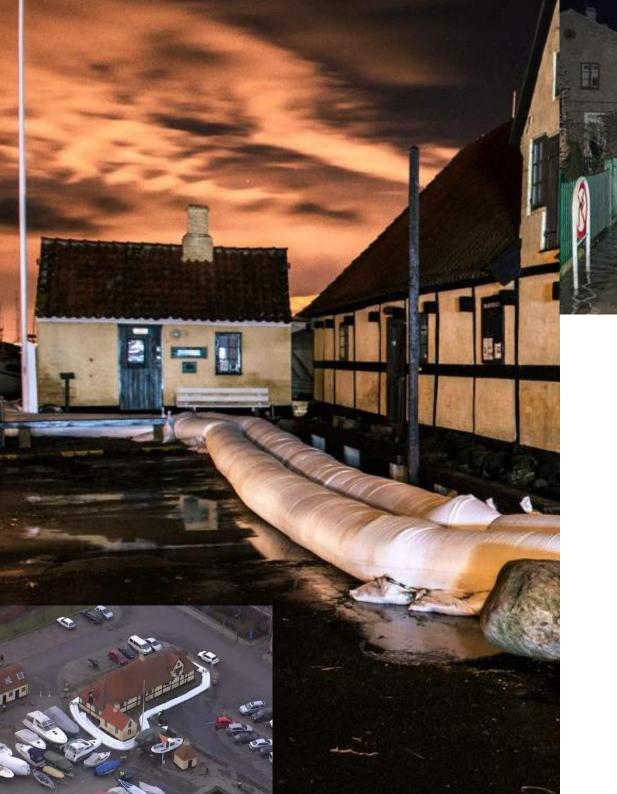
Dragør, Denmark

NoFloods Barriers save historical building

In Dragør Municipality the floodwater was expected to rise to 1.3 metres above its usual level during the storm. Among the different vulnerable areas and buildings, great attention was given to Dragør Museum: a 264-year-old historical building of great cultural value. The Museum is located very close to the water, and the weather forecast expected such an increase in the water level that it would have caused serious damage to the building. Approximately 100 metres of NoFloods Barriers were deployed to surround the museum, protecting it from the approaching water. That night was evidence of how this intervention could guarantee the protection of the Museum, while Environment Solutions is immensely proud of having provided equipment for the defence of national cultural heritage.

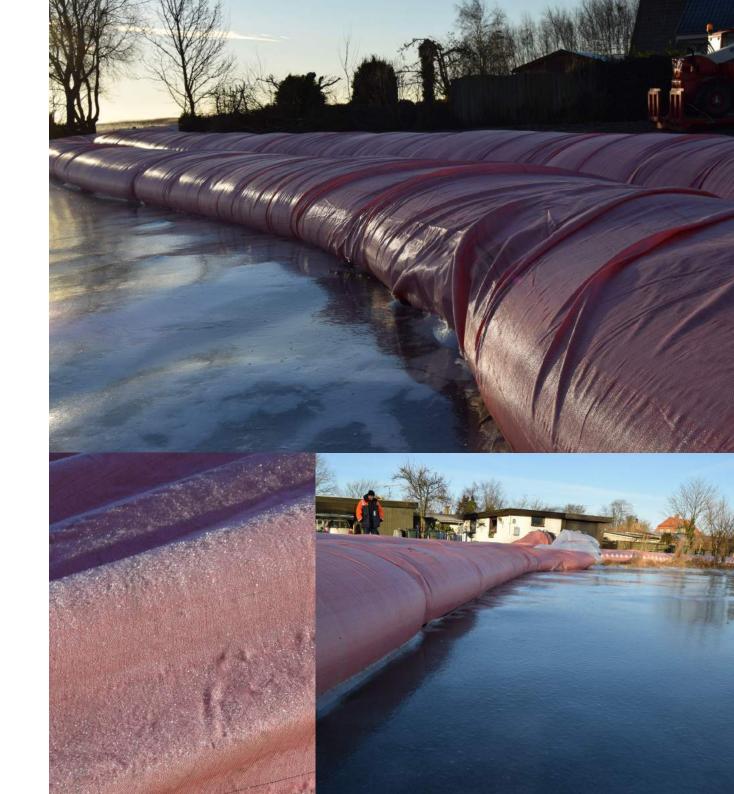
Jyllinge & Køge, Denmark

An icy morning

During those days, the temperatures were low and one morning well below freezing point, causing the water in and around the barrier to freeze. However, the efficiency of the NoFloods barriers was in no way compromised by the ice.

When the ice melted, the barriers were emptied and re-collected by the use of a hydraulic winch.
